NBSIR 73-222 (R)

Investigation of the Skyline Plaza Collapse in Fairfax County, Virginia

E. V. Leyendecker and S. G. Fattal

Final Report

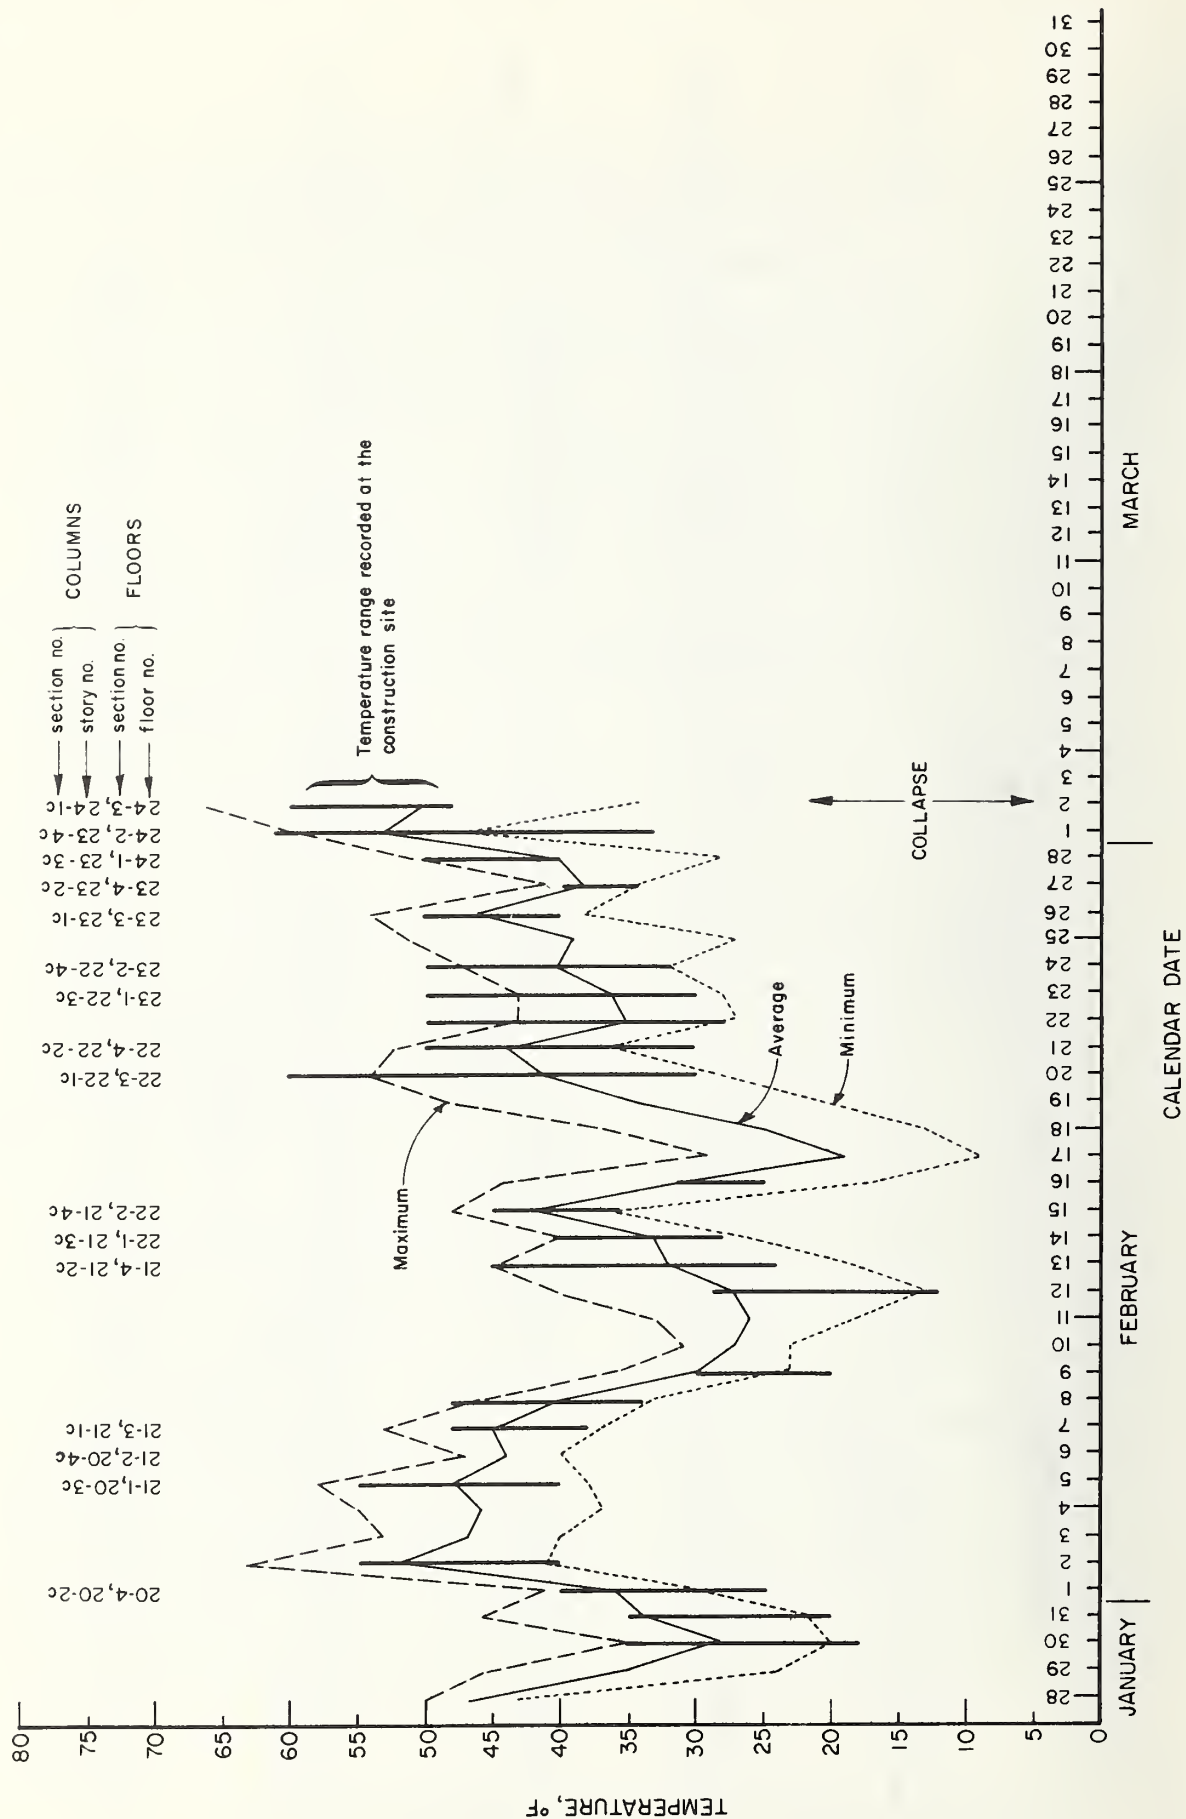
In order to convert these strengths into estimates at the time of collapse the curing temperature should be considered. The average temperature history has been shown in figure 3.5 (enlarged from figure 2.3). The average air temperature was 42°F for the 22nd floor and 45° for the 23rd floor (temperatures as recorded at National Airport). Estimates of strength using the Klieger data for 2 percent calcium chloride in figure 3.4 (and interpolating between temperature curves) yields the following results rounded to the nearest 10 psi:

Figure 2.3 TEMPERATURE AND CASTING HISTORY FOR 21st STORY AND UP

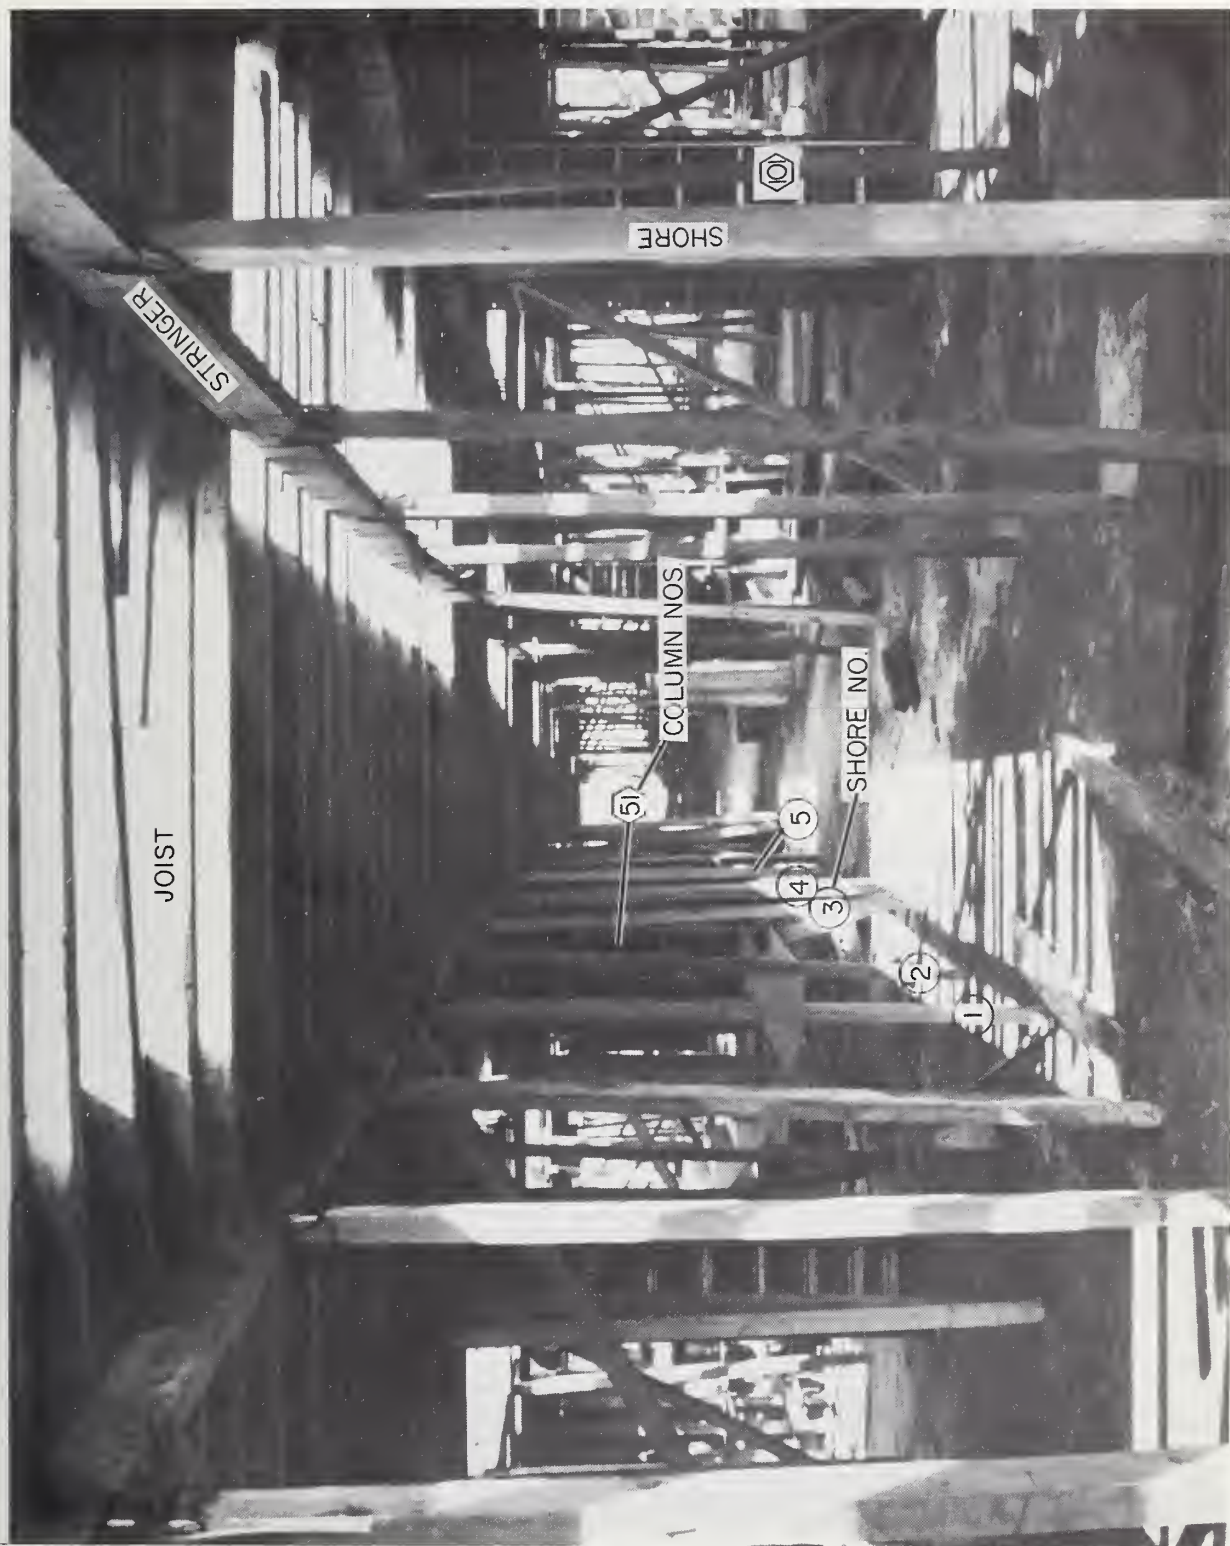
OSHA regulations (ANSI-A10.9, section 8.1.24) allow a maximum deviation of 1/8 in per 3 ft out of plumb. Deviations of shoring exceeding these limits were found on the 23rd (figure 2.20) and 24th (figure 2.16) stories.

Figure 2.16 Formwork in sections 1 and 2 of 24th story, looking east.

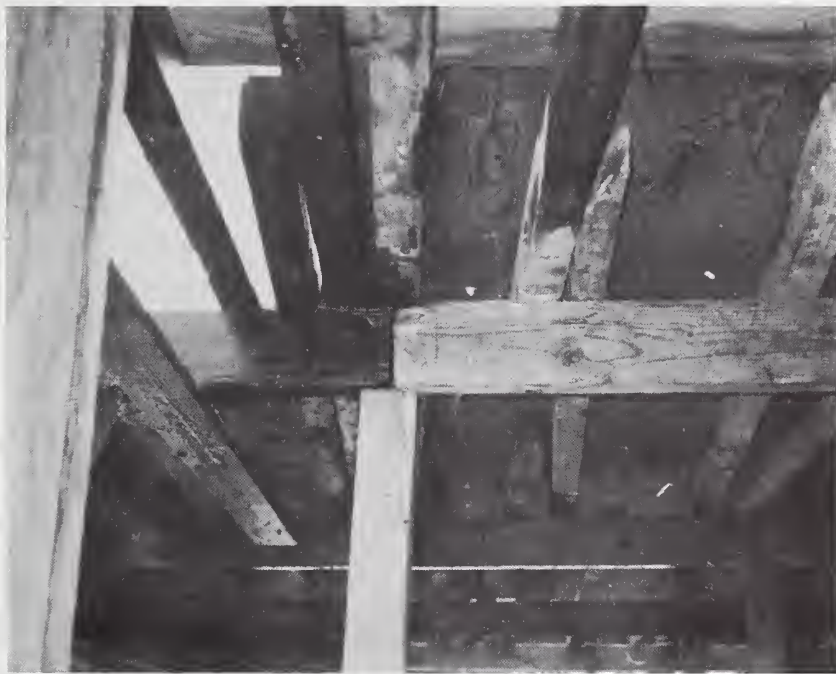
OSHA regulations (ANSI-A10.9, section 8.1.25) require removal of damaged or weakened shoring. On-site inspection after the incident indicates this was not done on the 23rd (figure 2.22) and 24th (figure 2.18) stories.

Figure 2.18 Selected details of 24th story forms.

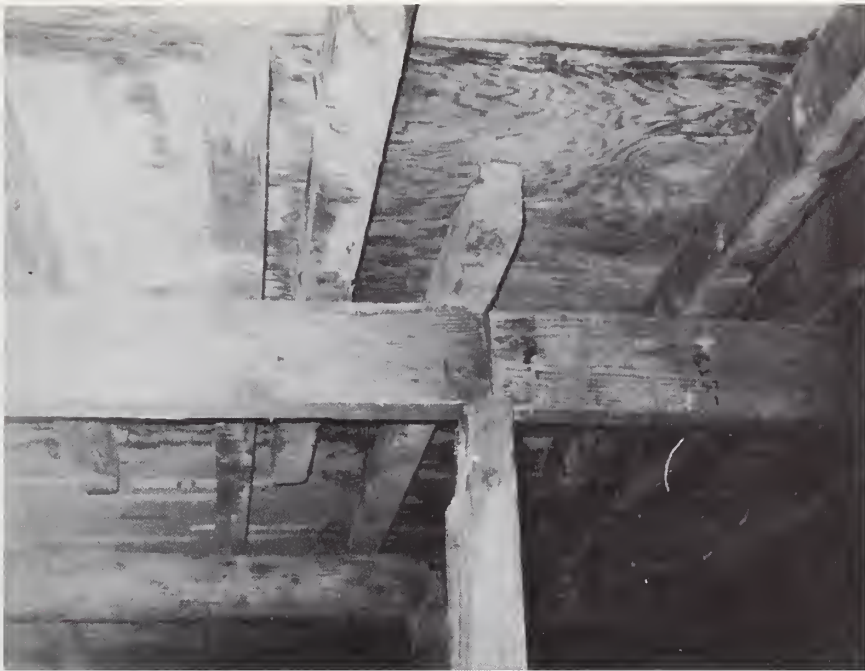
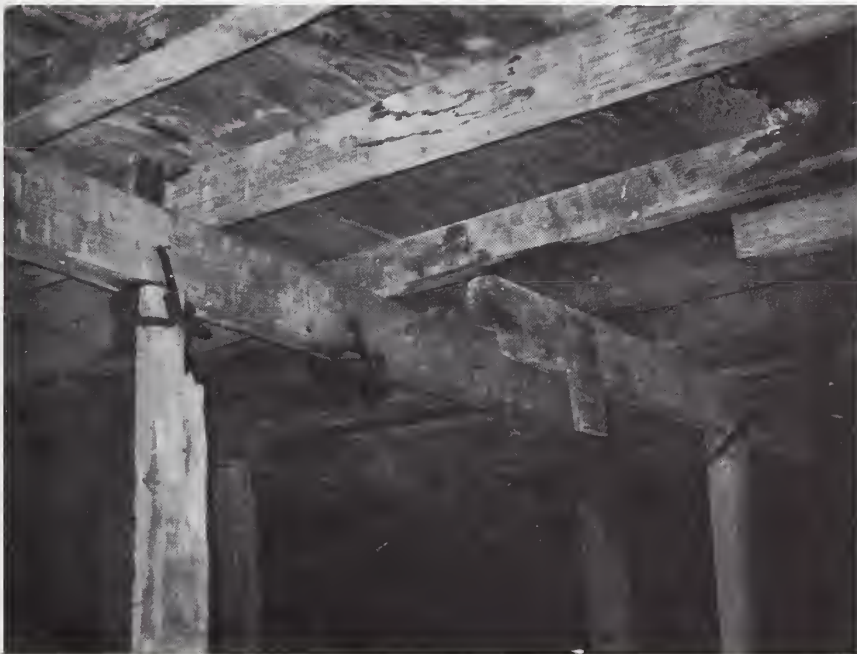
Figure 2.22 Selected details of 23rd story forms.

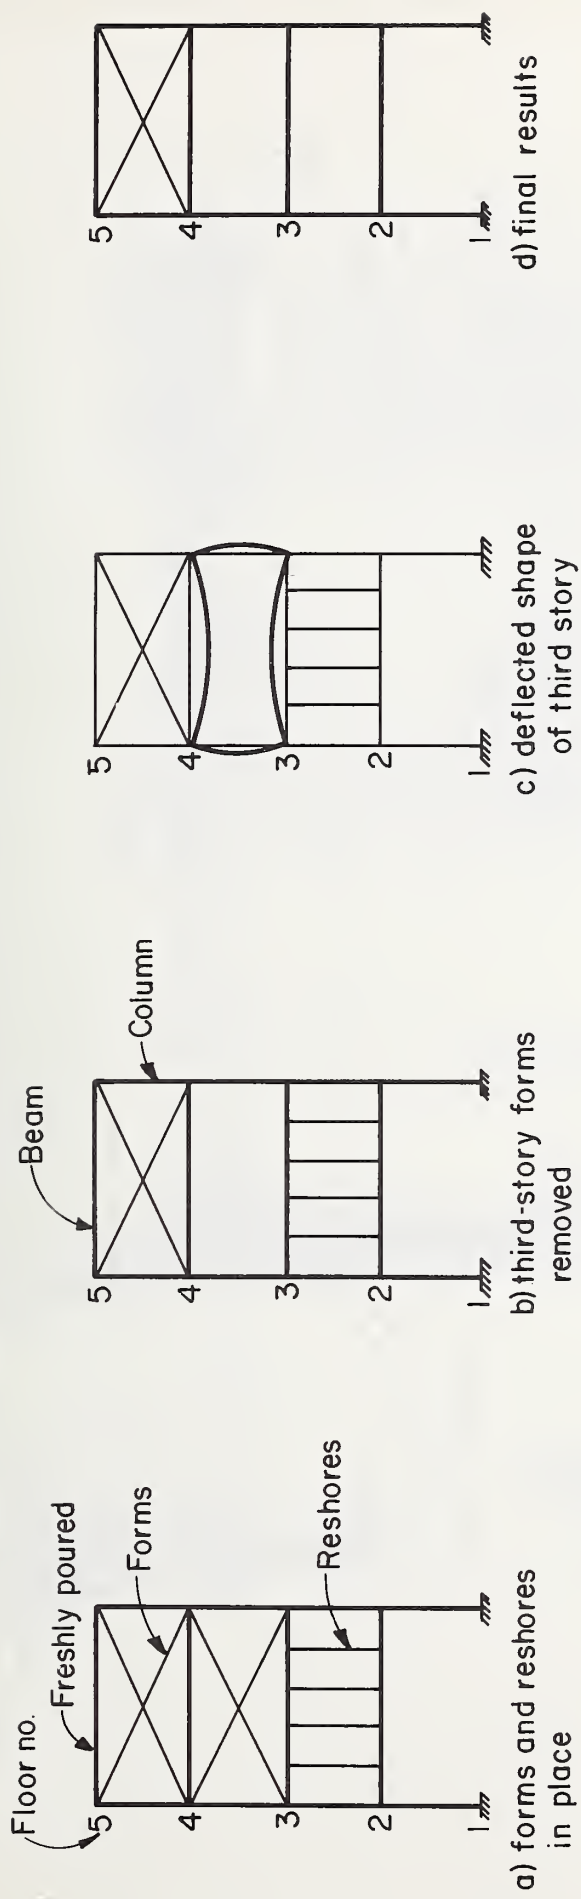
The effect of these two factors on the load distribution cannot be quantified because of insufficient information. However, the load distribution which would simultaneously mobilize both floors towards their respective shear capacities can be examined; a condition under which the combined resistance of both floors is a maximum. In this case, the total weight of three floors plus shoring in two stories would be distributed between the 22nd and 23rd floors in proportion to the square roots of their respective compressive strengths. The results indicated required compressive strengths of 1030 psi and 1115 psi for the 23rd and 22nd floors, respectively. These compare with 1200 psi and 1340 psi respective average values estimated for these floors. Consequently, failure under Case 4 loading cannot be precluded. However, the following evidence is taken as an indication that the collapse did not initiate in the 22nd floor slab: (a) employee statements did not indicate sagging of the 22nd floor slab at the time of collapse and (b) one employee statement indicating the loss of the 21st story reshores prior to the incident was interpreted as a decrease in the 22nd floor deflection (section 2.2.2 and figure 2.28).

Figure 2.28 Effect of removal of forms.

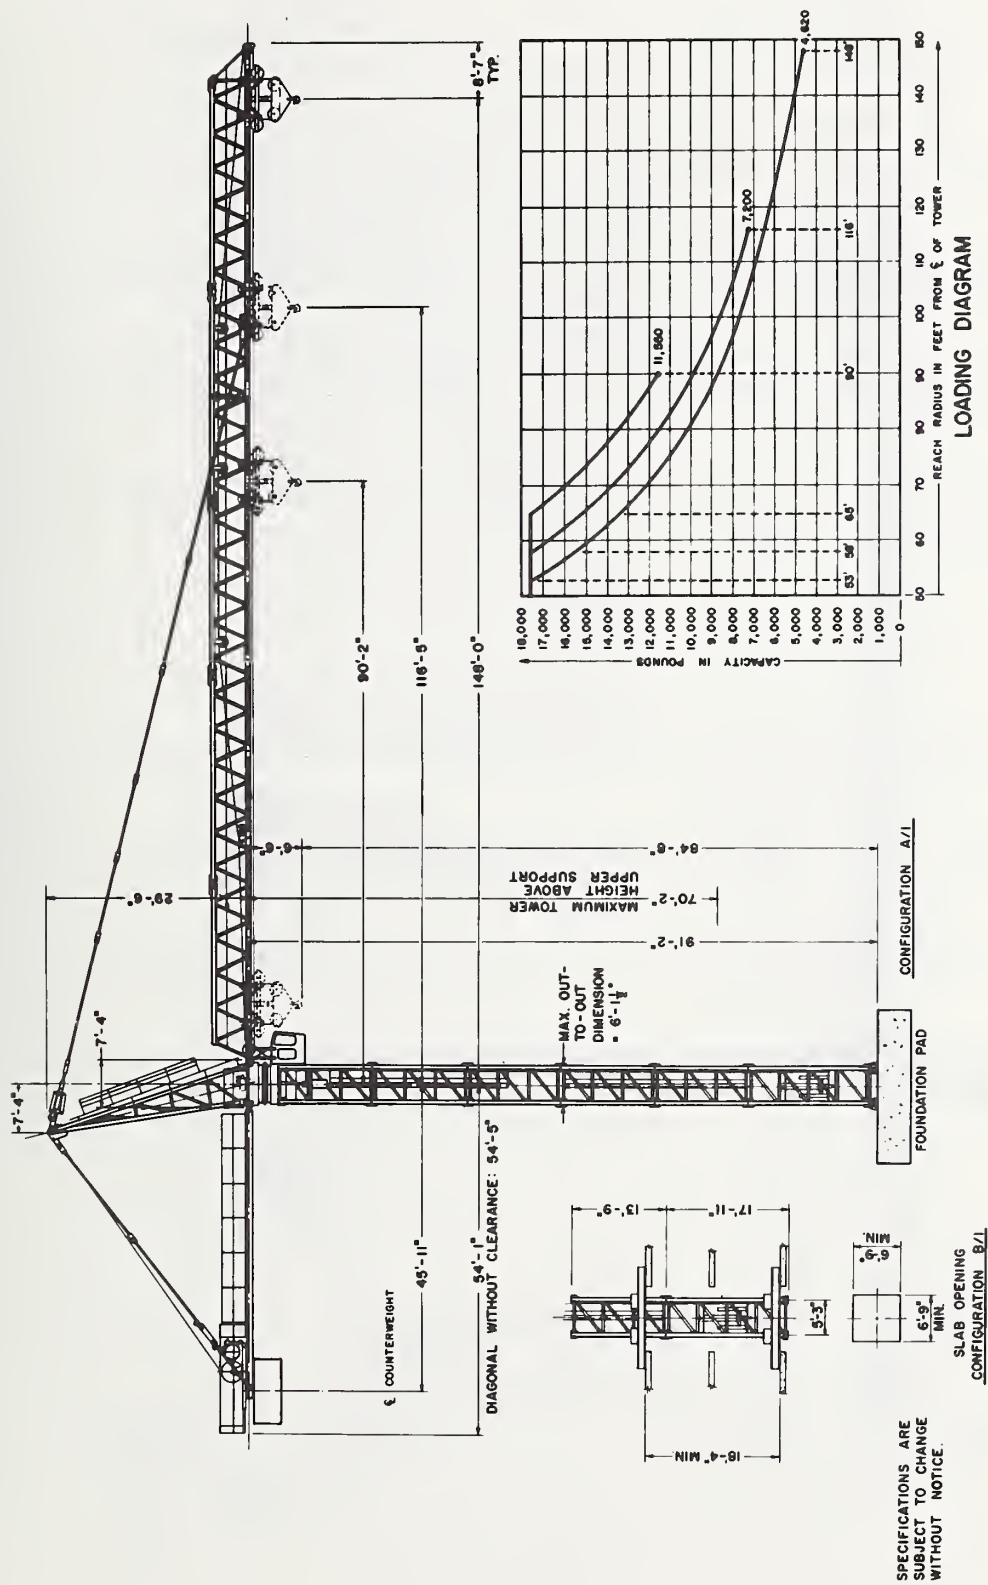
- (1) Crane no. 1 (in section 1, away from the collapse area) - distance between top and bottom supports was less than the required 18 ft 4 in (figure 2.30) (18 ft was used).
- (2) Crane no. 2 (in section 4, in the collapse area)- distance between top and bottom supports was less than the required 21 ft 4 in (18 ft was used).
- (3) Crane no. 2 (in section 4, in the collapse area) - The number of standard tower sections used was one more than the four recommended by the manufacturer (figure 2.41 and section 2.2.3).
- (4) Crane no. 2 (in section 4, in the collapse area) - The maximum tower height exceeded (by approximately one standard tower section) the 81 ft-0 in recommended (figure 2.31 and section 2.2.3).

Figure 2.30 Crane no. 1 specifications.

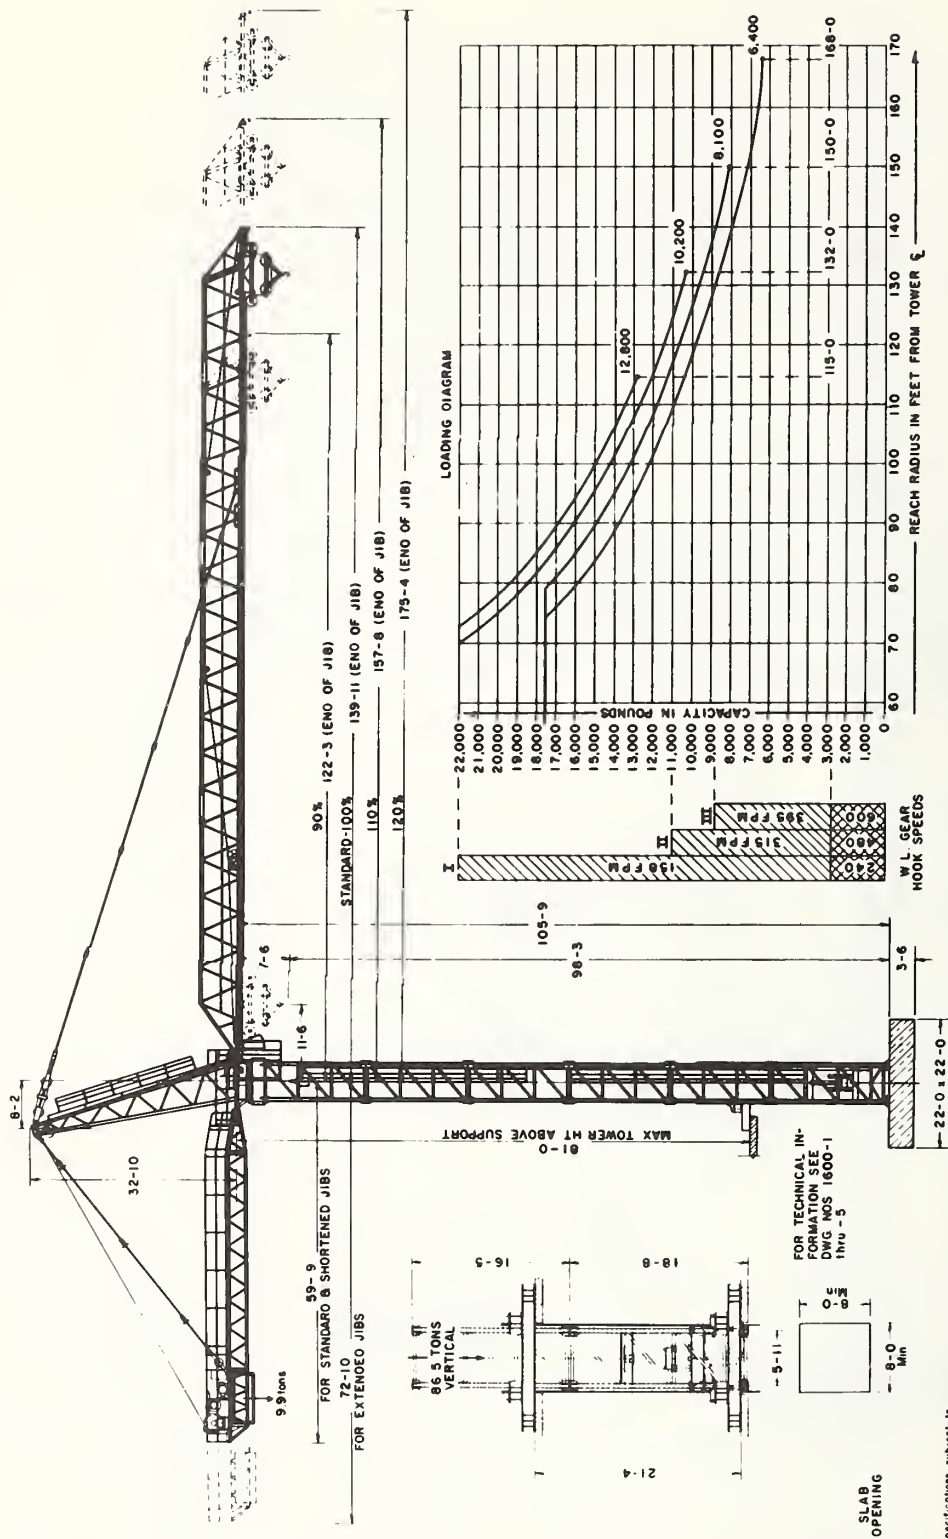
of 81 ft shown in figure 2.31. It is not known if any special precautions were taken to allow the difference between the actual and the recommended installation.

Figure 2.31 Crane no. 2 specifications.

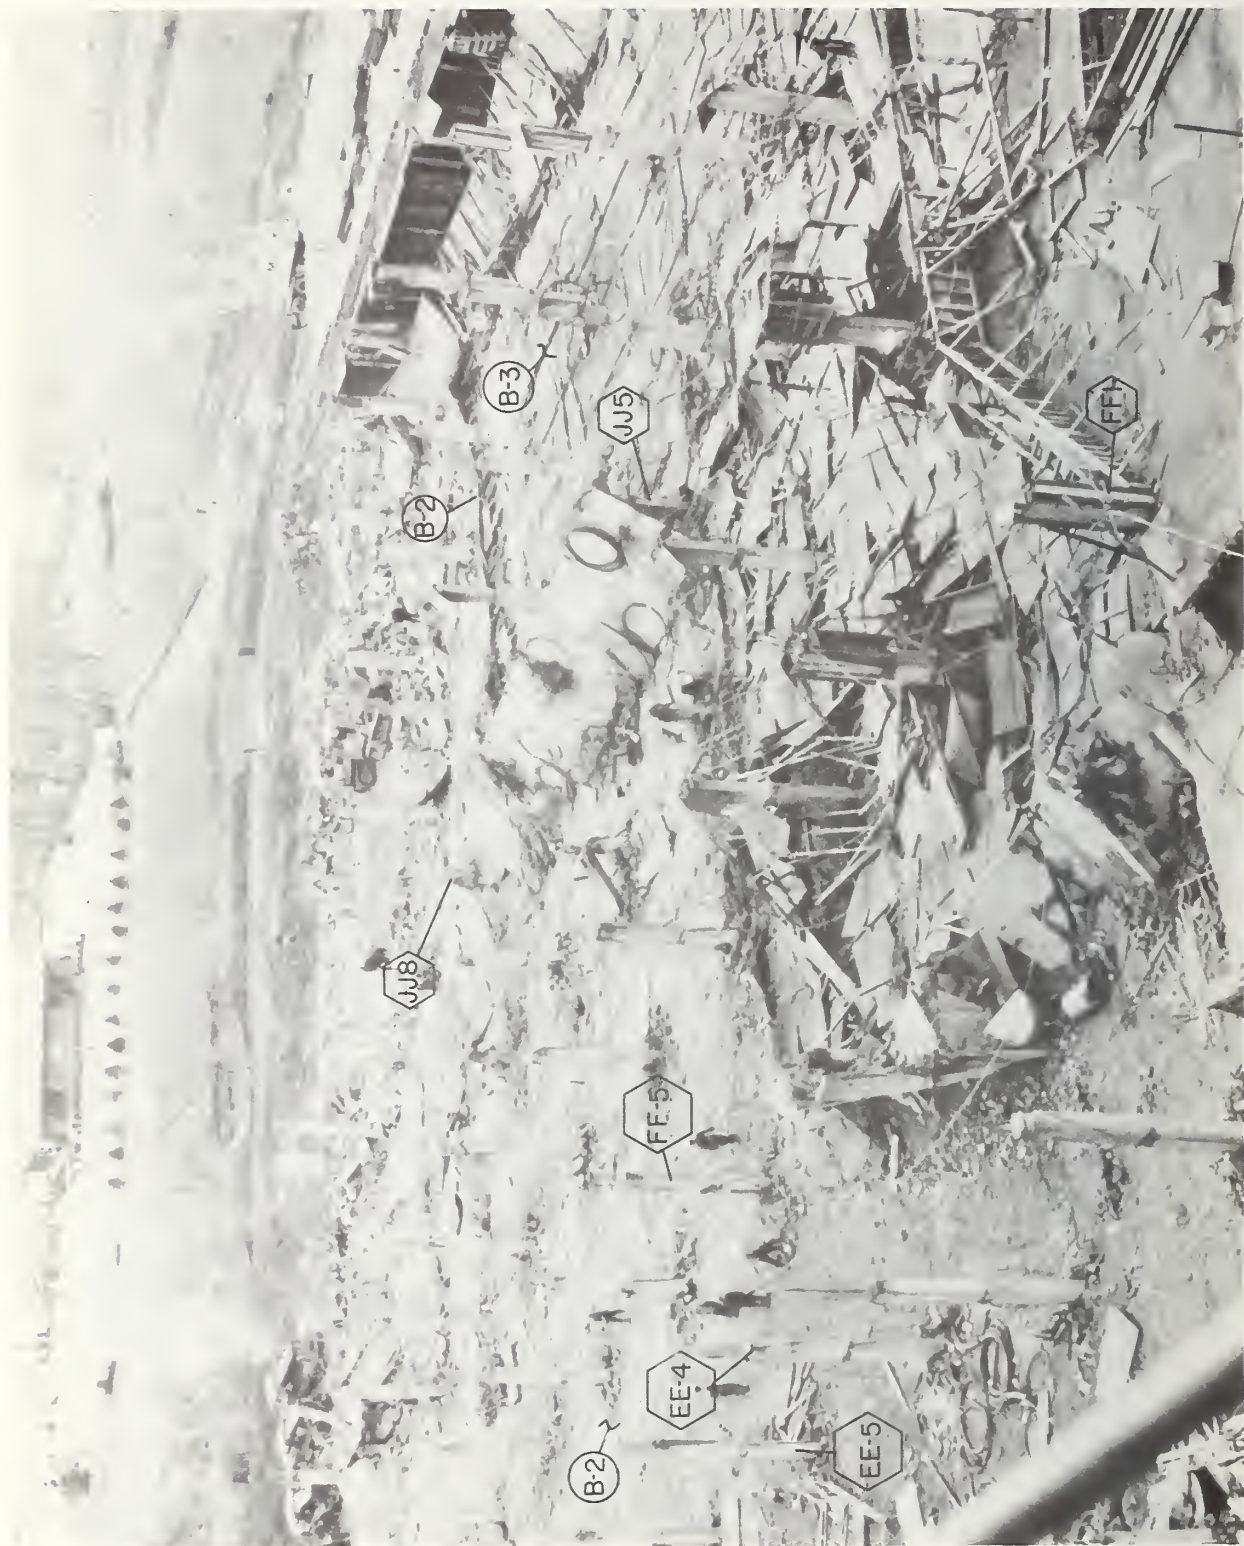
The parking garage, as seen from building A-4 is shown in figure 2.43. A number of columns have been identified for reference. At the time of the collapse, slab B-2 had been cast to the extent shown. The rest of B-2 had been formed (some of the forms had been cleared at the time of the photograph). A closeup of several of the columns in figure 2.43 are shown in figure 2.44.

Figure 2.43 General view of parking garage from building A-4.

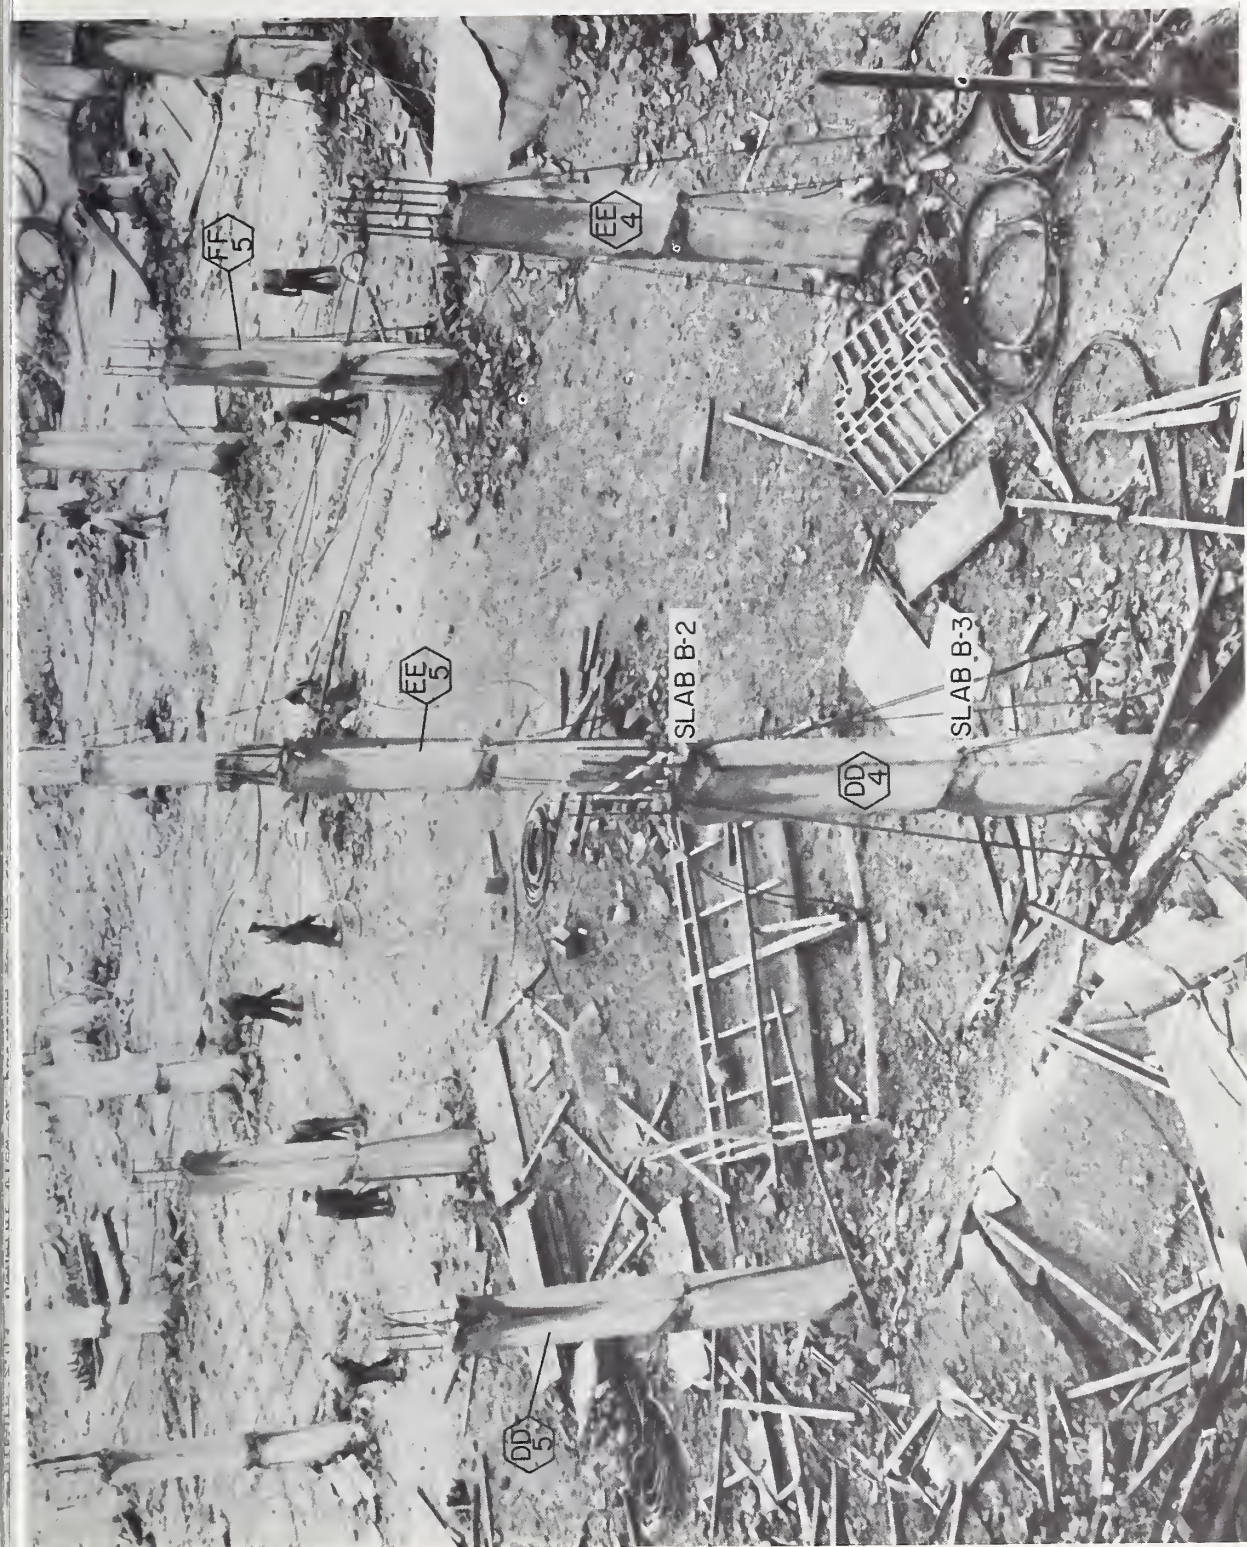
The locations of slabs B-3 and B-2 are shown in figure 2.44 on column DD-4. Note the virtual lack of shear cones at the slab levels on most of the columns in that figure.

Figure 2.44 Closeup view of columns in figure 2.43.

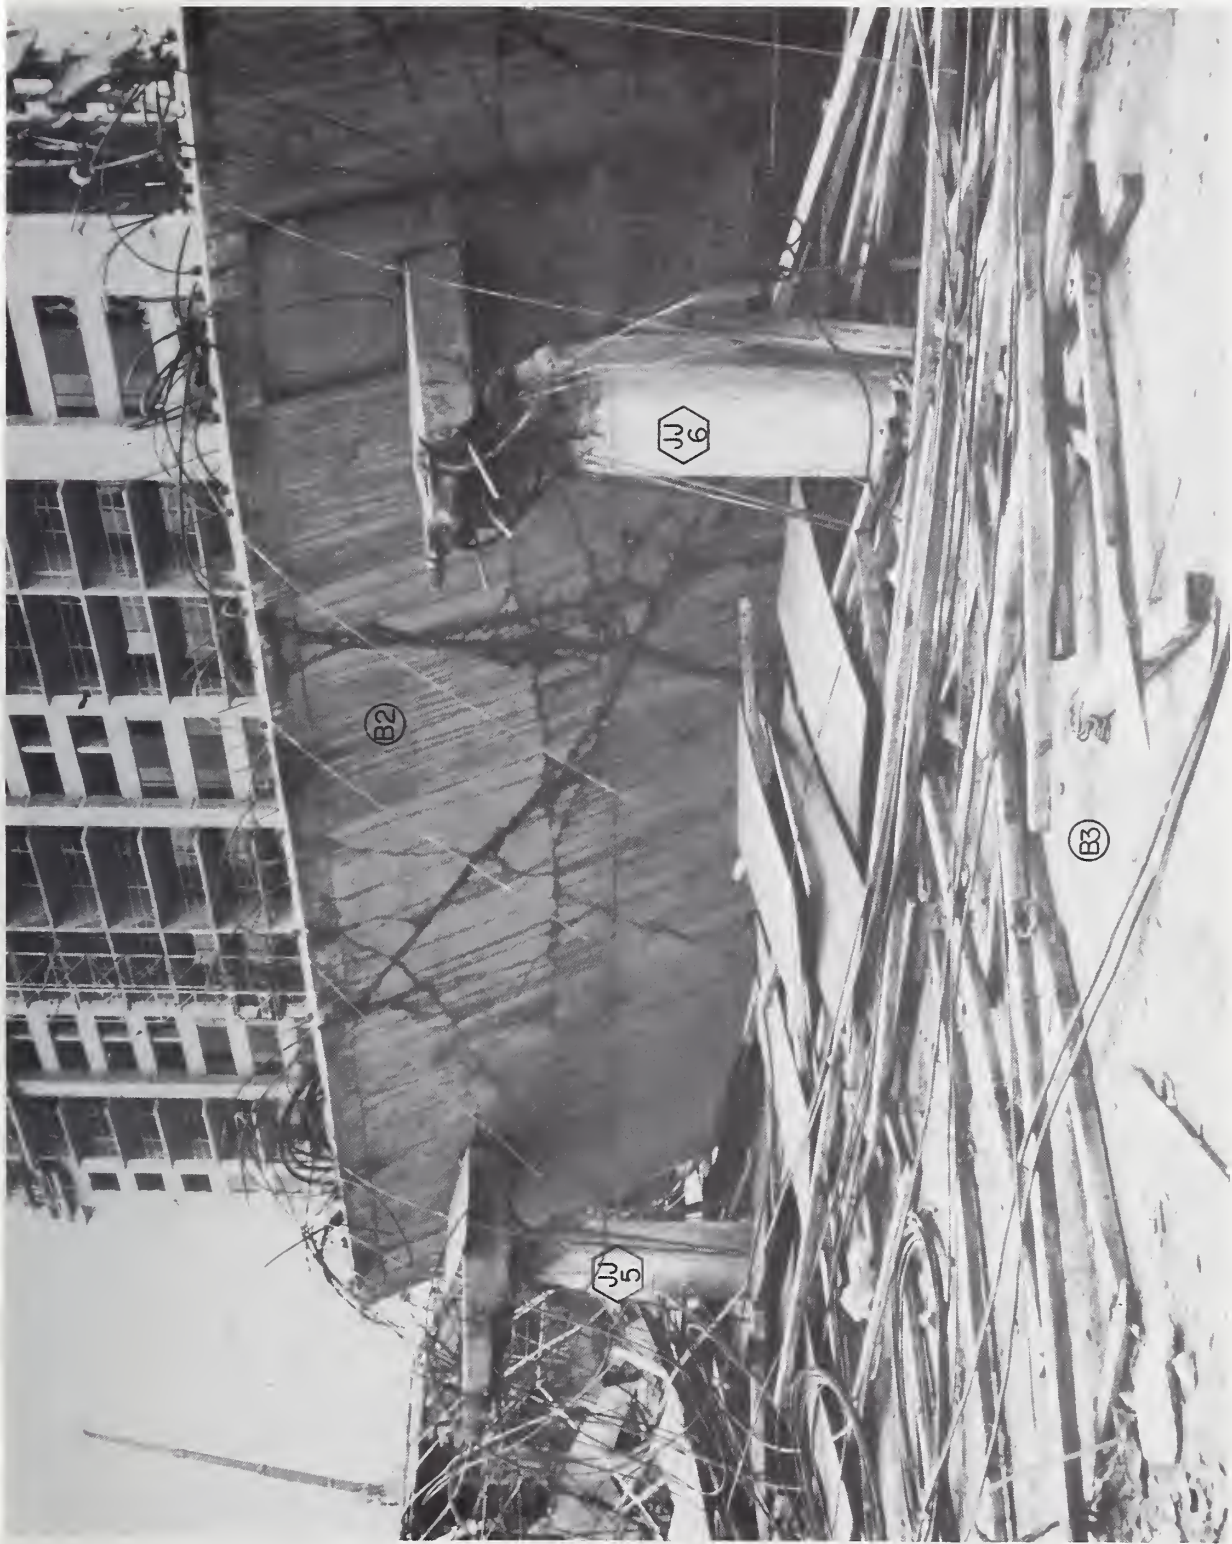
The garage slabs generally came "straight" down except near the slab edges. In the latter cases the columns usually failed in bending. Figure 2.45 shows a view of slab B-2 with the edge between columns JJ-5 and JJ-8 visible on the left. The view of this edge from the south is shown in figure 2.46. Note that the columns failed at the B-3 level. Formwork can be seen lying on top of the slab B-3. These forms apparently were in place under slab B-2.

Figure 2.46 Edge of slab B-2 at columns JJ-5 and JJ-6.

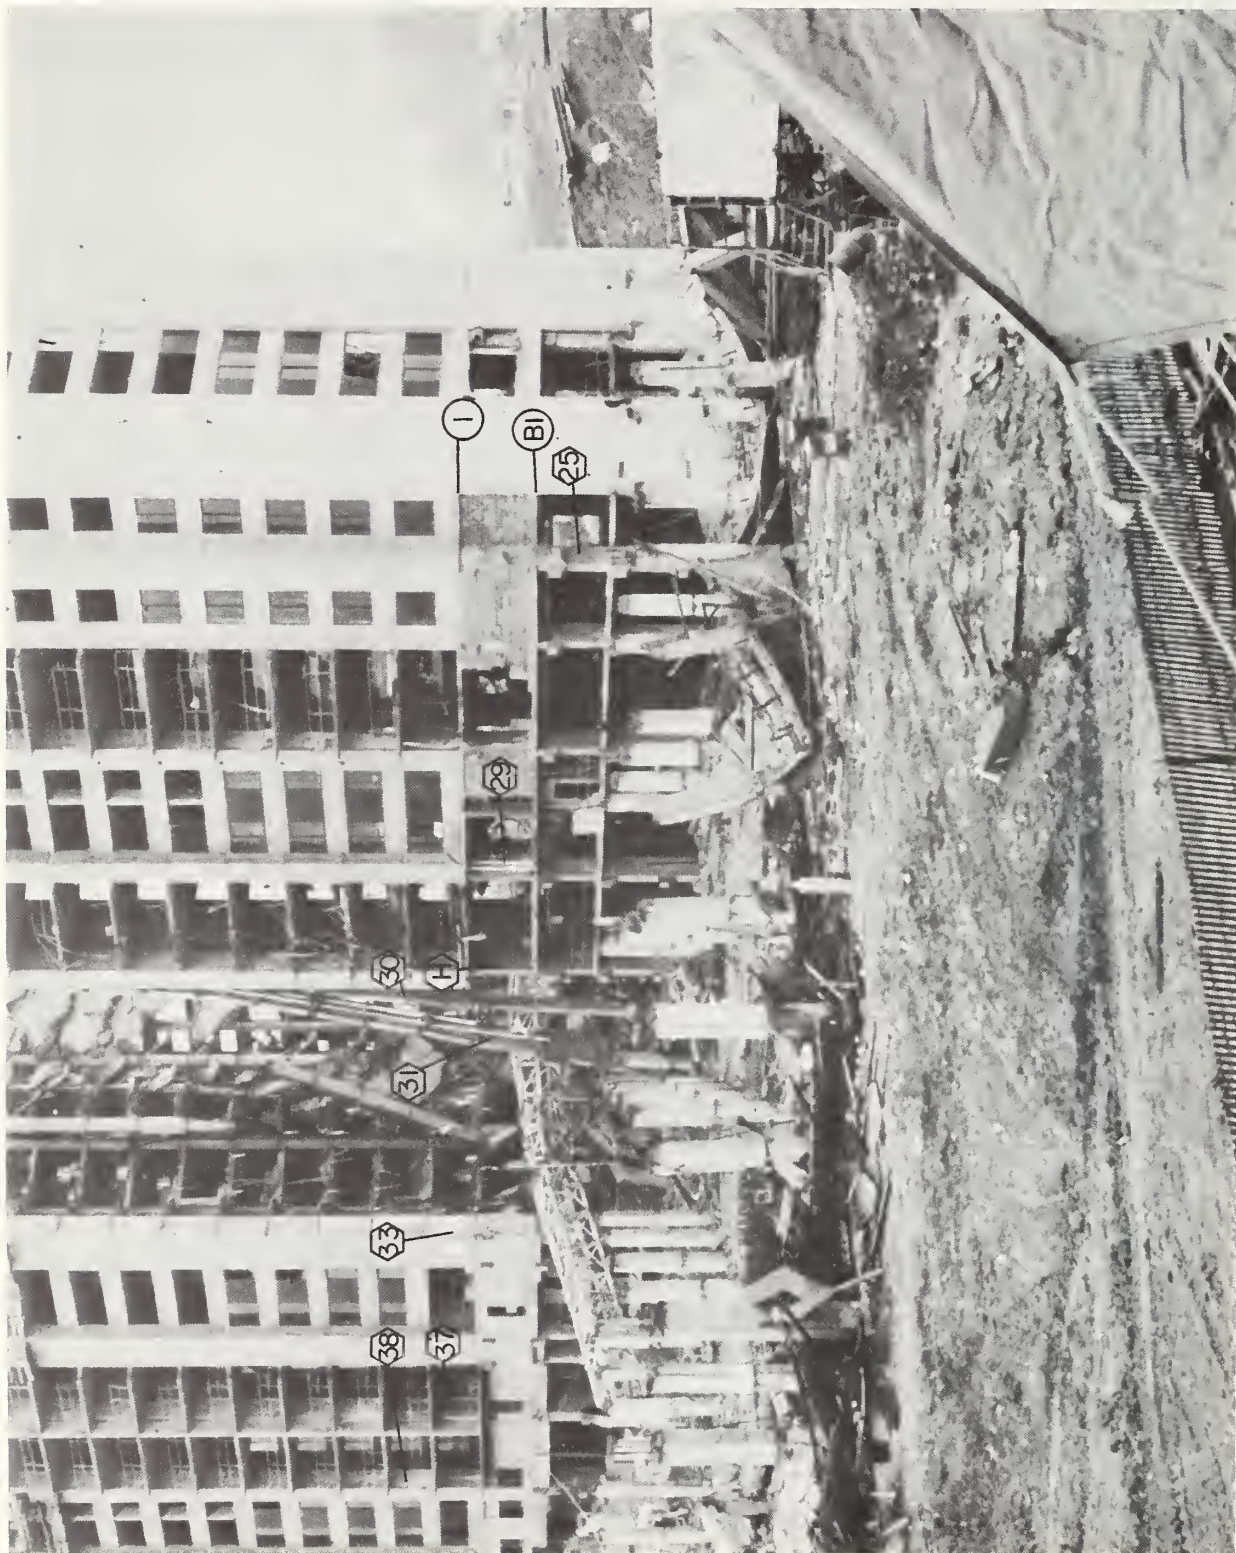
The east edge of the garage was supported by columns as shown in figure 2.49. The northern edge was simply supported by corbels on the columns. These corbels are visible in figures 2.49 and 2.50. The pool deck level (corresponding with the first floor of building A-4) was to rest on corbels on columns 25, 26, 27 and 33-37. Slab B-1 was to rest on corbels on columns 25, 26, 27, 29, 31-38, and shear wall H. Slab B-2 was supported by corbels on columns 25, 26, 27, 29, 31-38, and shear wall H. Slab B-3 was supported by corbels on columns 25, 26, 27, 29, 31-36, and shear wall H.

At the time of the collapse, crane No. 2 was reported idle with the jib pointed towards the garage. The exact orientation is not known. A distant view of the tower sections of the crane after the collapse may be seen in figures 2.49 and 2.51 (also 2.5). The tower top and hoist machinery (see figure 2.29) may be seen near column DD-2 in figure 2.55 (Note the partial shear cones on column DD-2). Based on an examination of the photographs it appears (refer to figure 2.1) that the crane tower lines up with the original position of the crane base (in plan view) and passes almost over columns 32 and DD-3, ending up with the top as shown in figures 2.55 and 2.56. This is a total distance of 125 to 130 ft. This distance compares to a total tower height (base section, 5 standard sections, and 1 slipring section) of about 125 ft. The implication here is that the tower fell while rotating about its original plan position. However, careful inspection of figures 2.54, 2.55, and 2.5 shows the jib is lying alongside the tower sections. The sequence of

Figure 2.49 View of garage area looking northwest showing crane no. 2 and column corbels on building A-4.

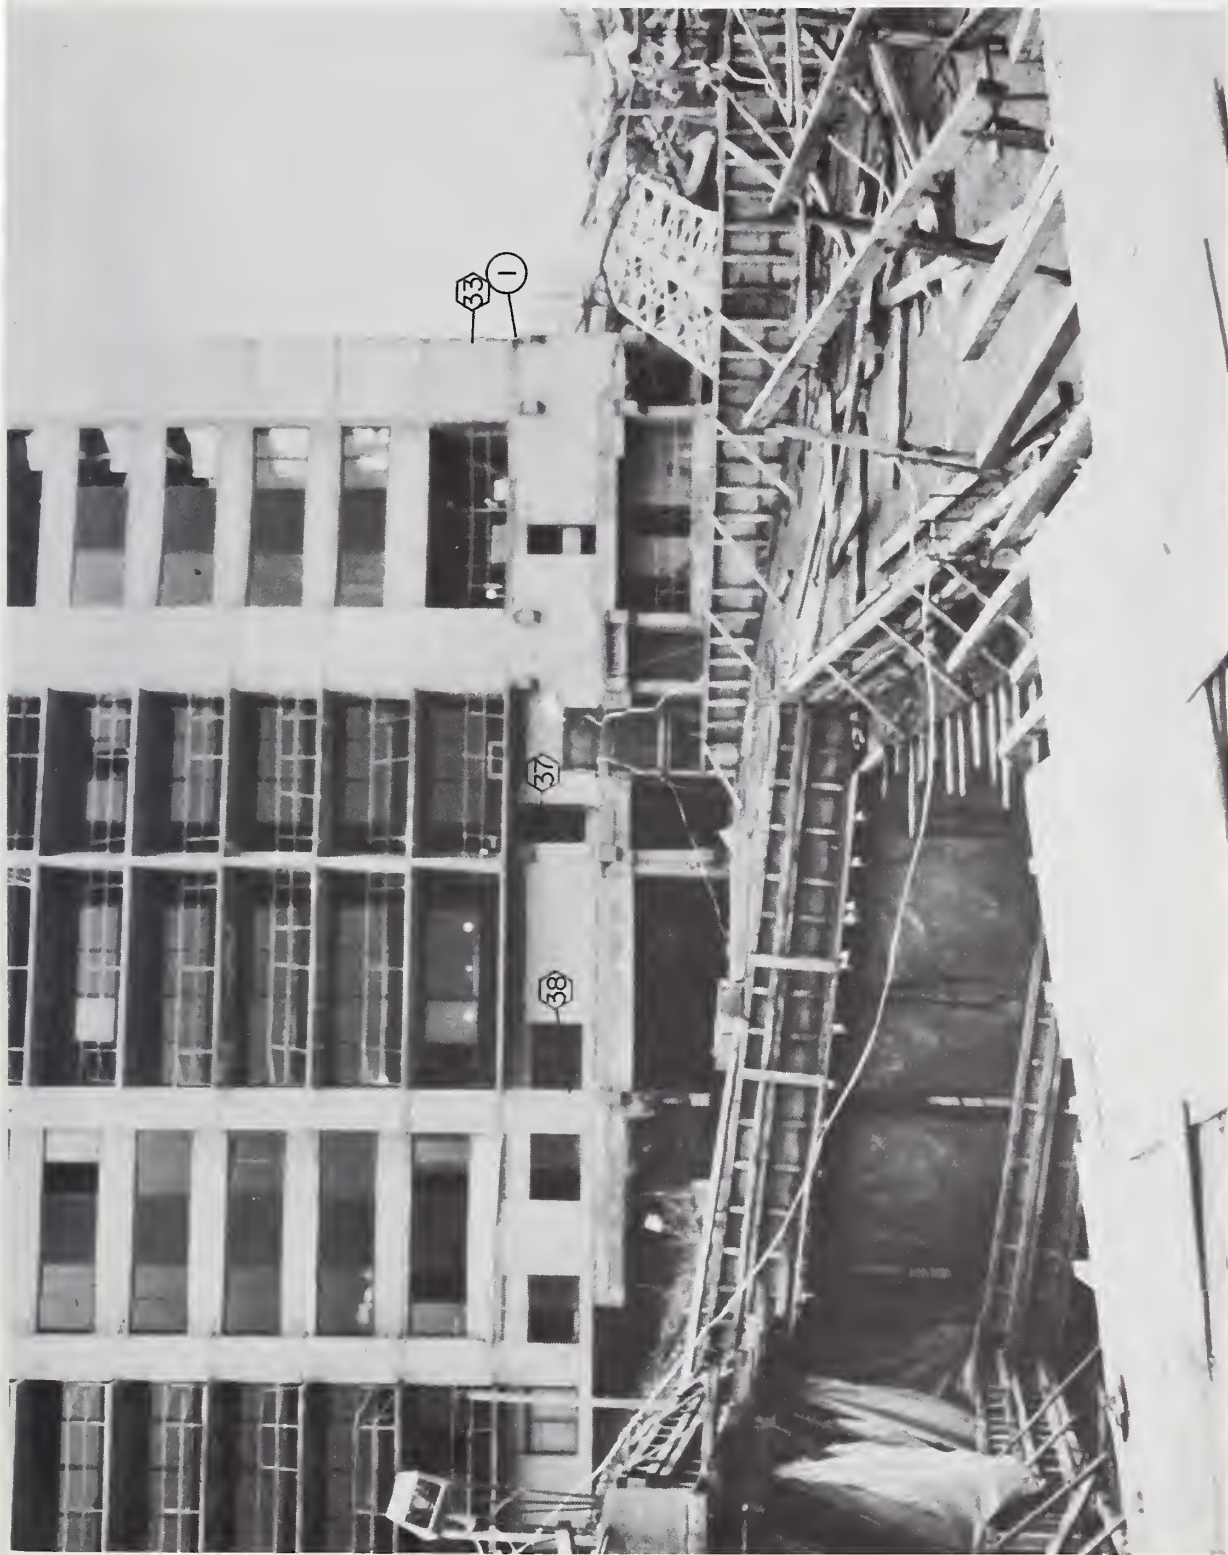
Figure 2.50 View looking north of ramp area and column corbels on building A-4.

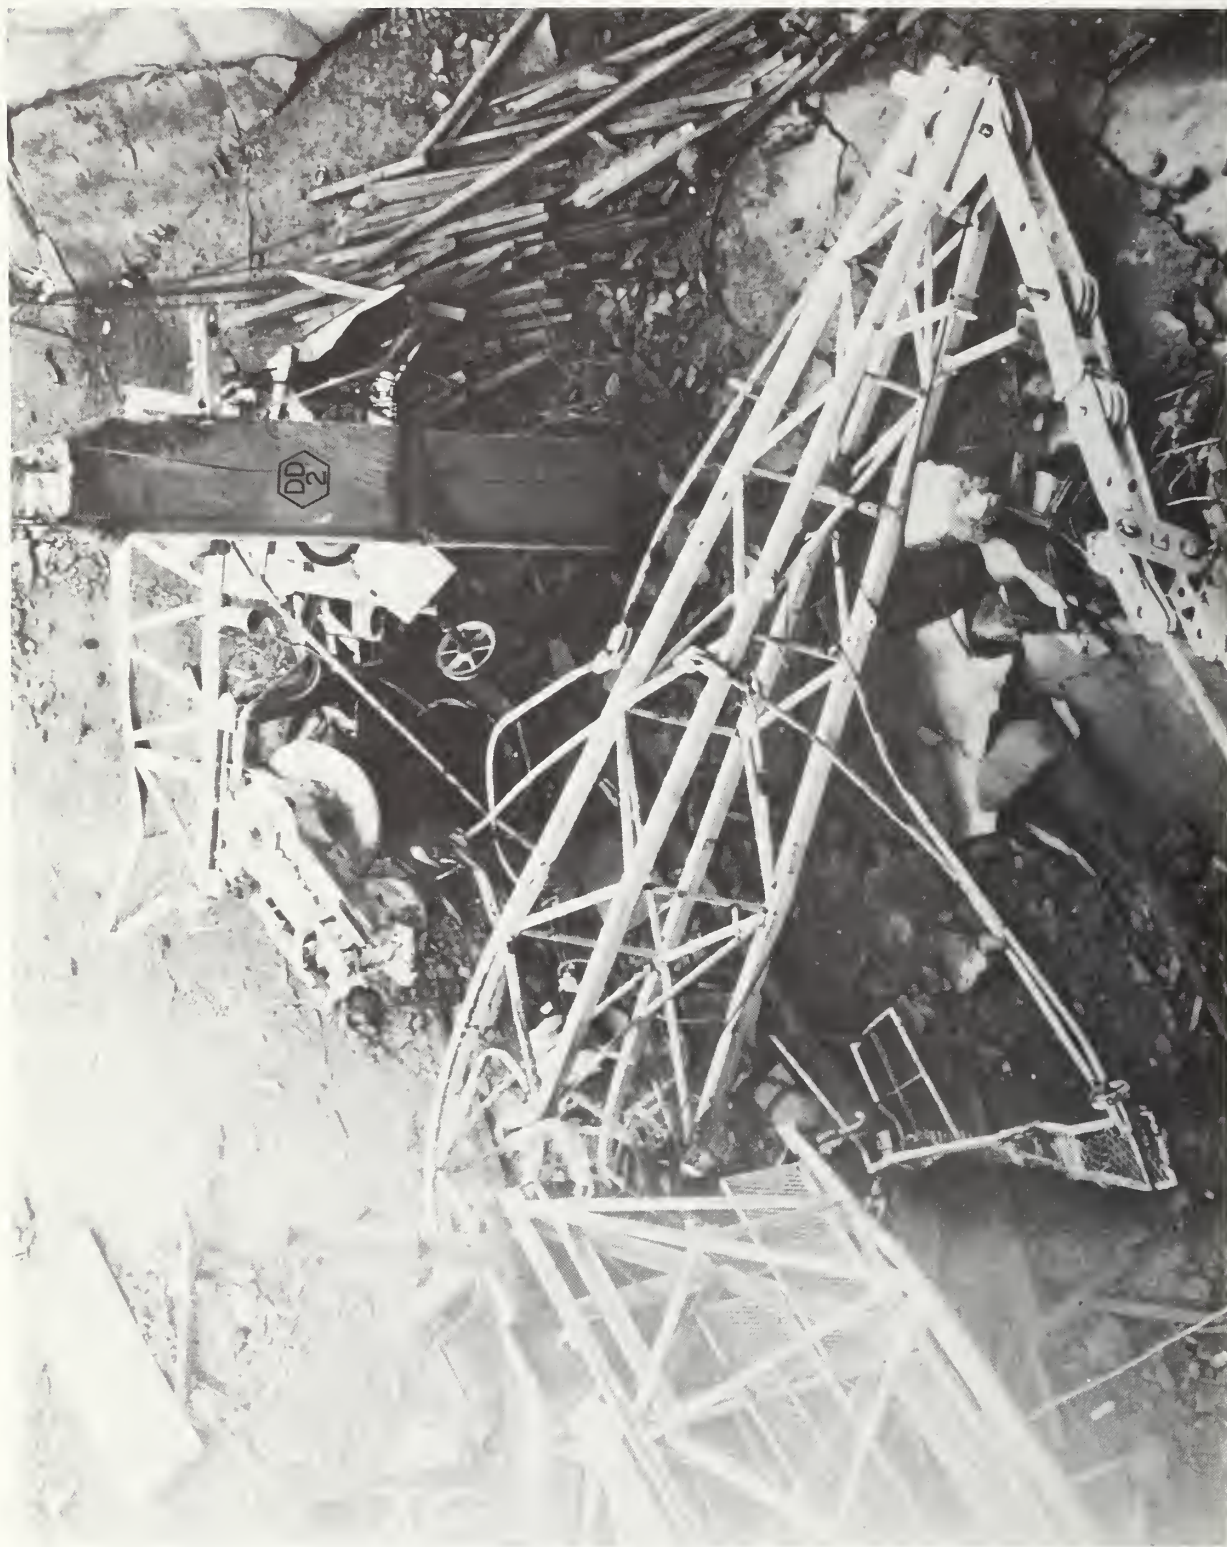
Figure 2.55 Position of fallen crane near column DD-2 looking south.
